Restoration report

Instrument: Hofner Jumbo (Western??)

Model : not determined but presumed to be a derivative of Hofner 491 (Selmer 5154)
courtesy of Hofner GmB

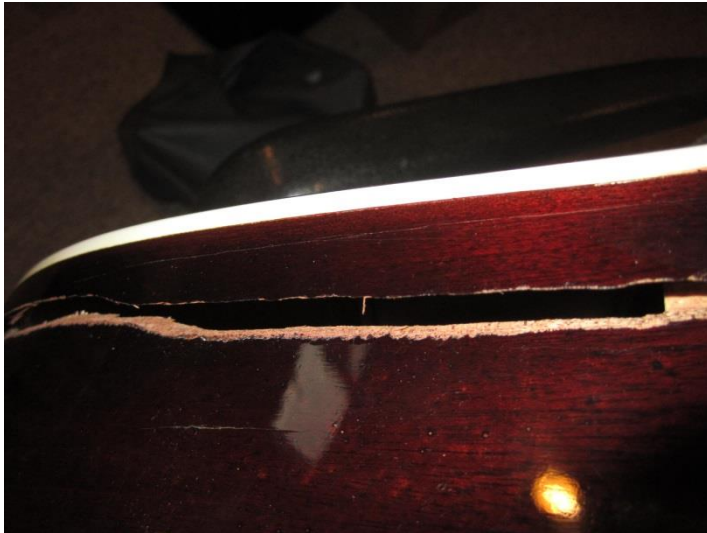
The treble sidewall was massively damaged by two enormous cracks and was embedded into the body with a penetration measuring approximately 2.5" to 3". It was very clear that something had pushed hard against the instrument to the effect that the sidewall gave way allowing penetration. The damage presented as two tears running in parallel from just short of the end block to just short of the neck block. It was rather obvious that complimentary internal damage was also suffered.

The process begins. Shown here is the crack under the sound board after the section was sprung outwards back into its original position. Both cracks were individually more than 25 inches long.

The first part was to determine if the damaged sidewall could be pushed back out to a more normal condition. This proved rather easy and the side wall basically sprang out as soon as it was pushed from the inside. The instability of the structure no doubt helped.

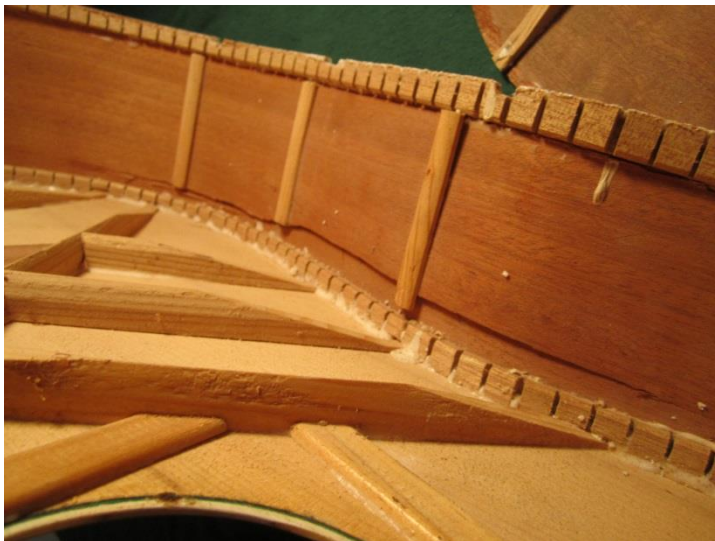
The cracks viewed from the inside

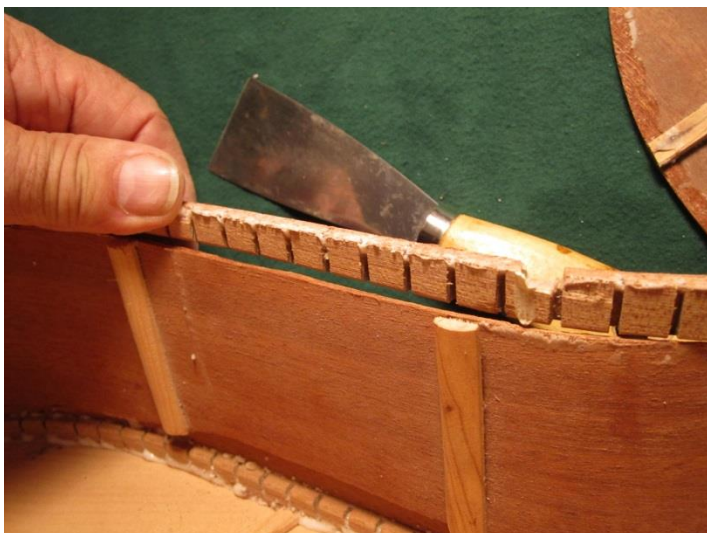
2. The upper of the two cracks (close to the back) also ran close to rear kerfing. The rear kerfing was also damaged in several areas but thankfully most of this was separation rather than destructive damage.

A further view of the crack close to the back. Basically only a narrow strip of wood / kerfing was all that remained to hold the side in place after the damaging incident.

5. The same process was performed on the second crack (closest to the back) but on this occasion having already completed the first crack, the structure was much more stable. It should be mentioned that strategic vertical braces were employed during the gluing of the second crack. Once both cracks were complete, the final parallel vertical bamboo braces were added.

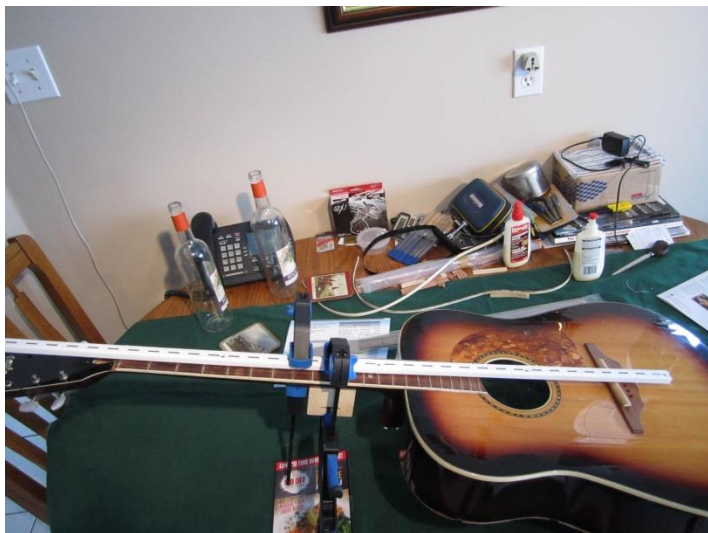
The steel bar was used to stabilise the structure after the back was removed. This stayed in place until the back was reattached.

The removal of the back destroyed any minimal structural integrity that remained. This had to be stabilised temporarily to allow and assessment of the full damage and subsequently to maintain integrity until the damage could be repaired. To achieve this end, the truss rod was backed off until the finger board could be dialled in as flat. A steel bar was now clamped in place on the finger board and extended to the bridge where again it was clamped. Careful attention was given to make sure the correct geometry between, neck, body, bridge and saddle was attained. This then allowed the restoration to proceed.

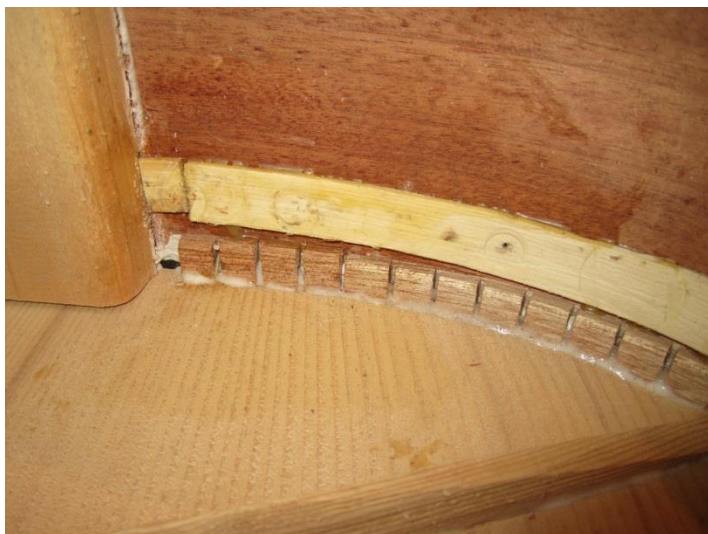
The thin bamboo strip, preformed and used to bring the edges of the crack into a perfect alignment. This strip is only 1/16" thick and was preformed wet to fit perfectly above the kerfing and across the worst damage to the side.

1. The kerfing on the lower bout was damaged and no longer effective. This was made much worse as the lower (close to the sound board) of the two massive cracks ran through this area. Thin bamboo strips were soaked and preformed to reinforce the whole bout and also to hold the crack in a proper alignment. Bamboo was chosen in this case as, even in a small thin section, it is immensely strong but remains flexible. In addition to this Bamboo has a much higher natural frequency than the tone wood of the guitar and as such would not affect the tonal responses of the instrument

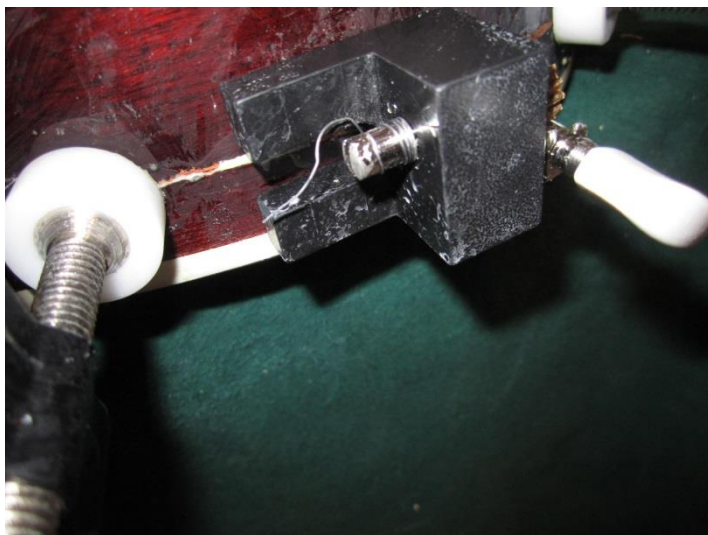
Typical clamping to ensure the body curve was maintained and the crack properly aligned. Many clamps of various types were utilised to get it all in perfect alignment.

4. The crack closest to the sound board was now prepared for repair and aligning. This was more difficult than expected. Several test methods of crack stabilisation were employed included cleats and different clamping. One may appreciate the difficulties when it is borne in mind that the cracks were around 25" long and they circumnavigated the both bouts and the waist of the guitar. This was compounded by the fact that the whole crack had to be stabilised, clamped and glued all in one shot. Several mock up dummy runs were had until an acceptable process was established.

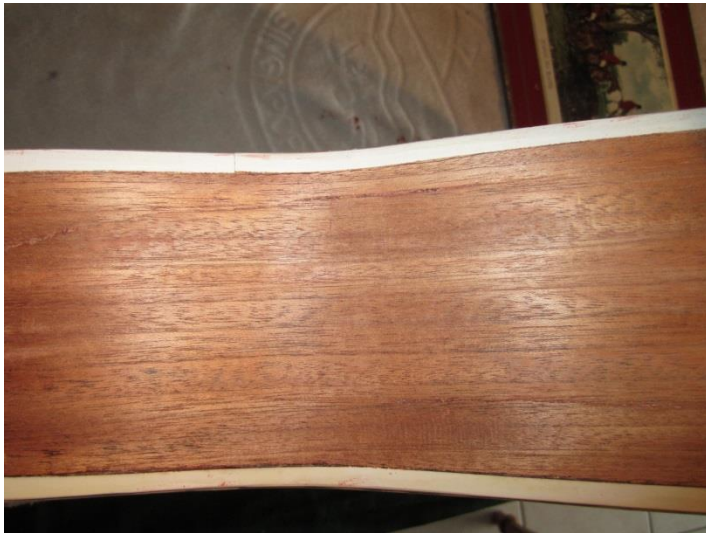
Now you see them now you don't. the cracks after repair and ready for refinishing. The final result certainly justified the care taken to get it right.

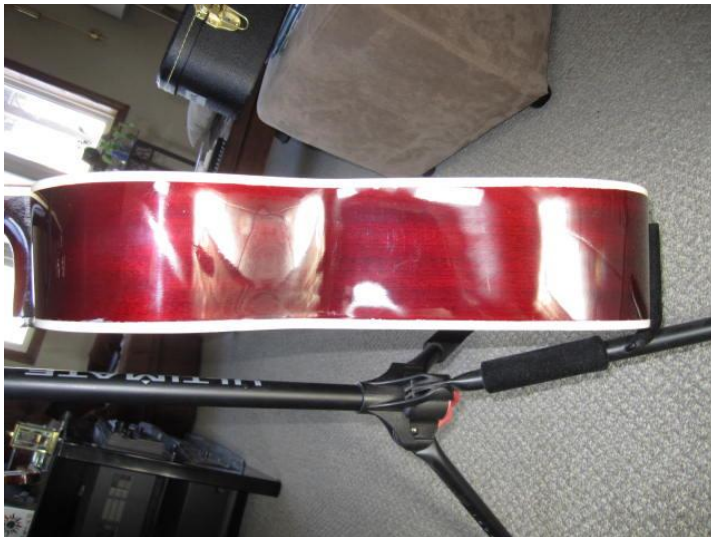
This is how the same area looks now.

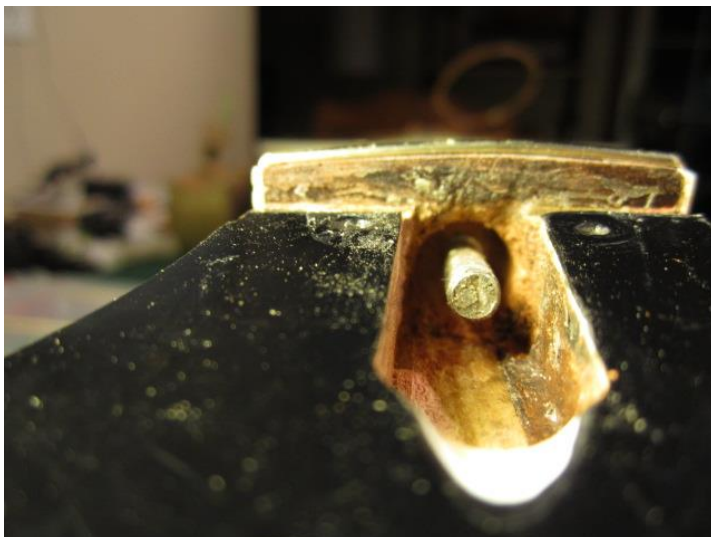
The neck was a typical five piece with the main construction being three-piece sandwich with an Indian Rosewood finger board. The three piece portion of the neck had separated in the area of transition between the neck and the machine head. It was clear that the truss rod may have had something to do with this separation.

The truss rod after the damaged wood was removed. by a special trepanning cutter.

8. Attention now turned to the neck where the seized truss rod nut had already been removed at an earlier stage. A special trepanning boring bit was now inserted over the truss rod and damaged old wood removed. This allowed the separated neck portion to be clamped back into the original position and re-glued. Thereafter, a hard Honduras Mahogany tapered plug was made and glued into position restoring the function of the truss rod and also reinforcing the part of the neck that had separated previously. Structurally this was better than new.

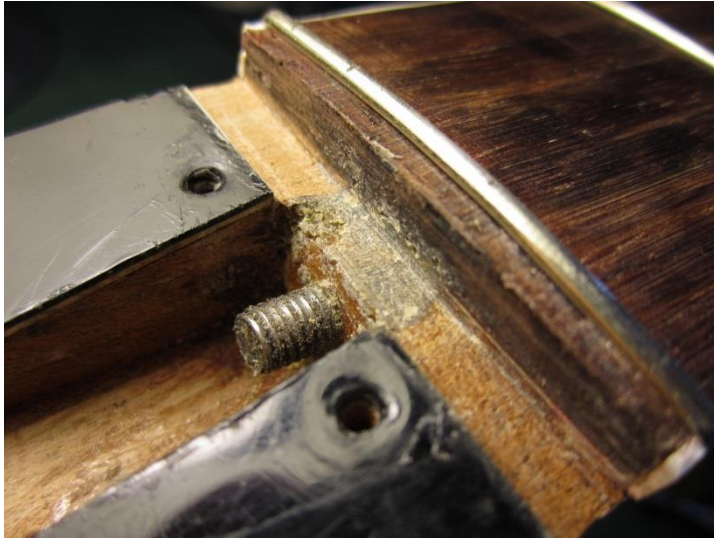
The mahogany plug in position ready to finish.

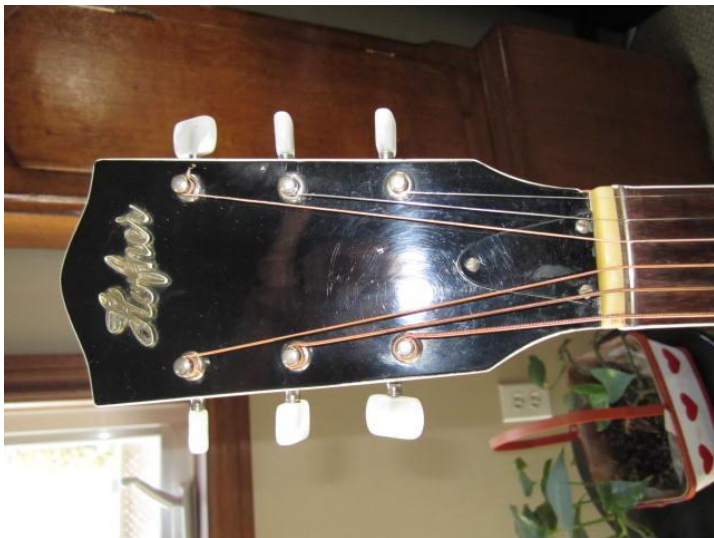
She now looks like new with new nut, saddle and reworked bridge.

7. During the course of the restoration, the bridge had been removed as it was partially separated. The original intention was to make a new bridge but this was abandoned as it would not be original. The original bridge was reworked and reattached.

11. A full set up with a new bone saddle and nut were made and installed to complete the work.
12. The beauty and tone of this unique Hofner has been more than restored and she has been played and admired by many.

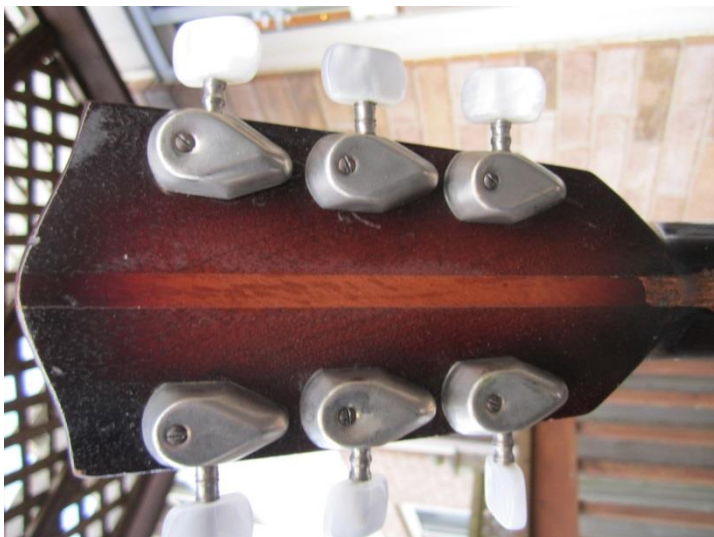
Tuners completely rebuilt just like new.

9. And finally, the tuners were refurbished before being reinstalled.
10. Having completed all the structural work of restoration, the old finish was removed and the body of the instrument was refinished as close as possible to the original as it came from Hofner so many years before. The neck was deliberately not refinished and the repair to the neck was left as testament to the work and authenticity of this lovely instrument. Not refinishing the neck may well meet with disagreement but that is the way it was done. This does not preclude refinishing in the future.
