Restoration report

Instrument: Hofner Jumbo (Western??)

Model : not determined but presumed to be a derivative of Hofner 491 (Selmer 5154)
courtesy of Hofner GmB

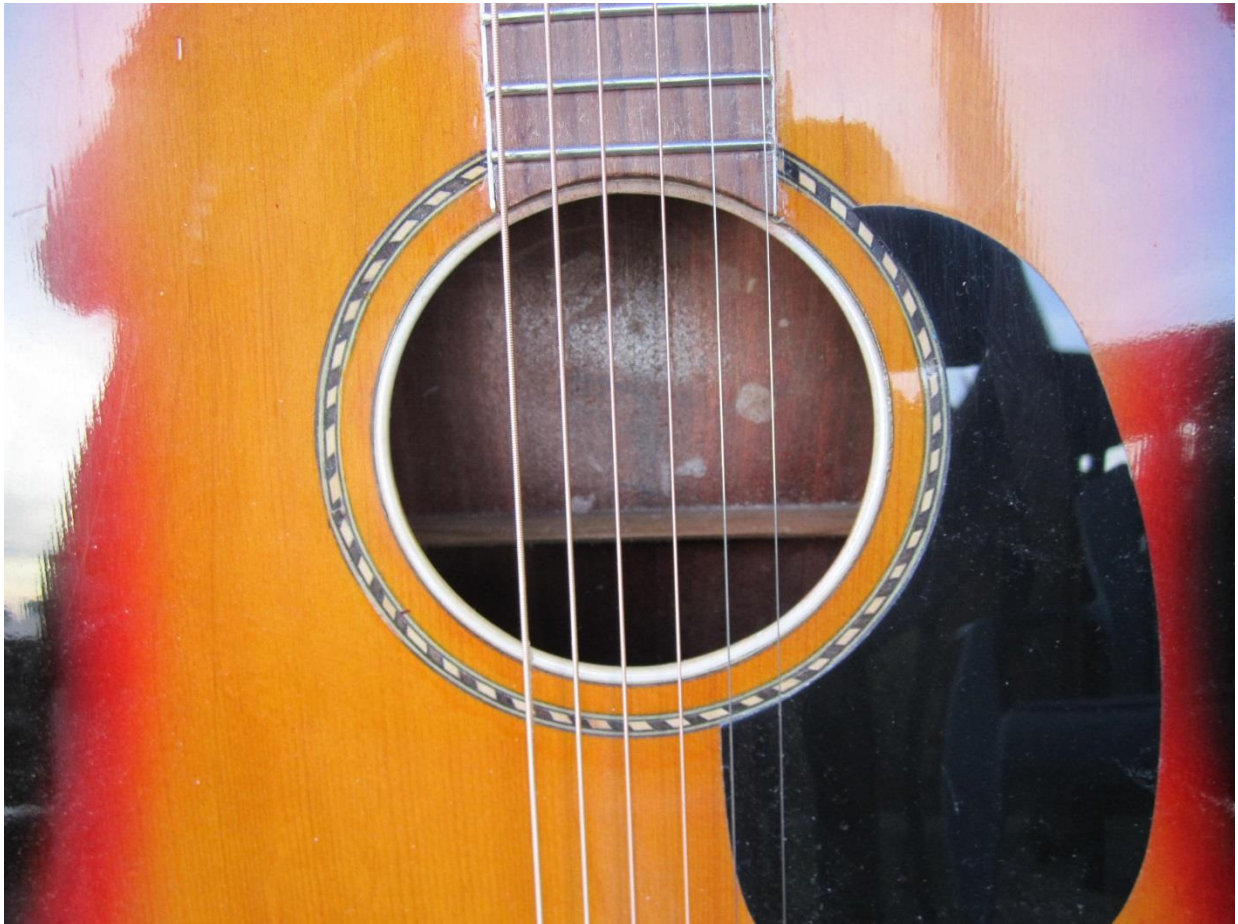
Tuners completely rebuilt just like new.

9. And finally, the tuners were refurbished before being reinstalled.
10. Having completed all the structural work of restoration, the old finish was removed and the body of the instrument was refinished as close as possible to the original as it came from Hofner so many years before. The neck was deliberately not refinished and the repair to the neck was left as testament to the work and authenticity of this lovely instrument. Not refinishing the neck may well meet with disagreement but that is the way it was done. This does not preclude refinishing in the future.

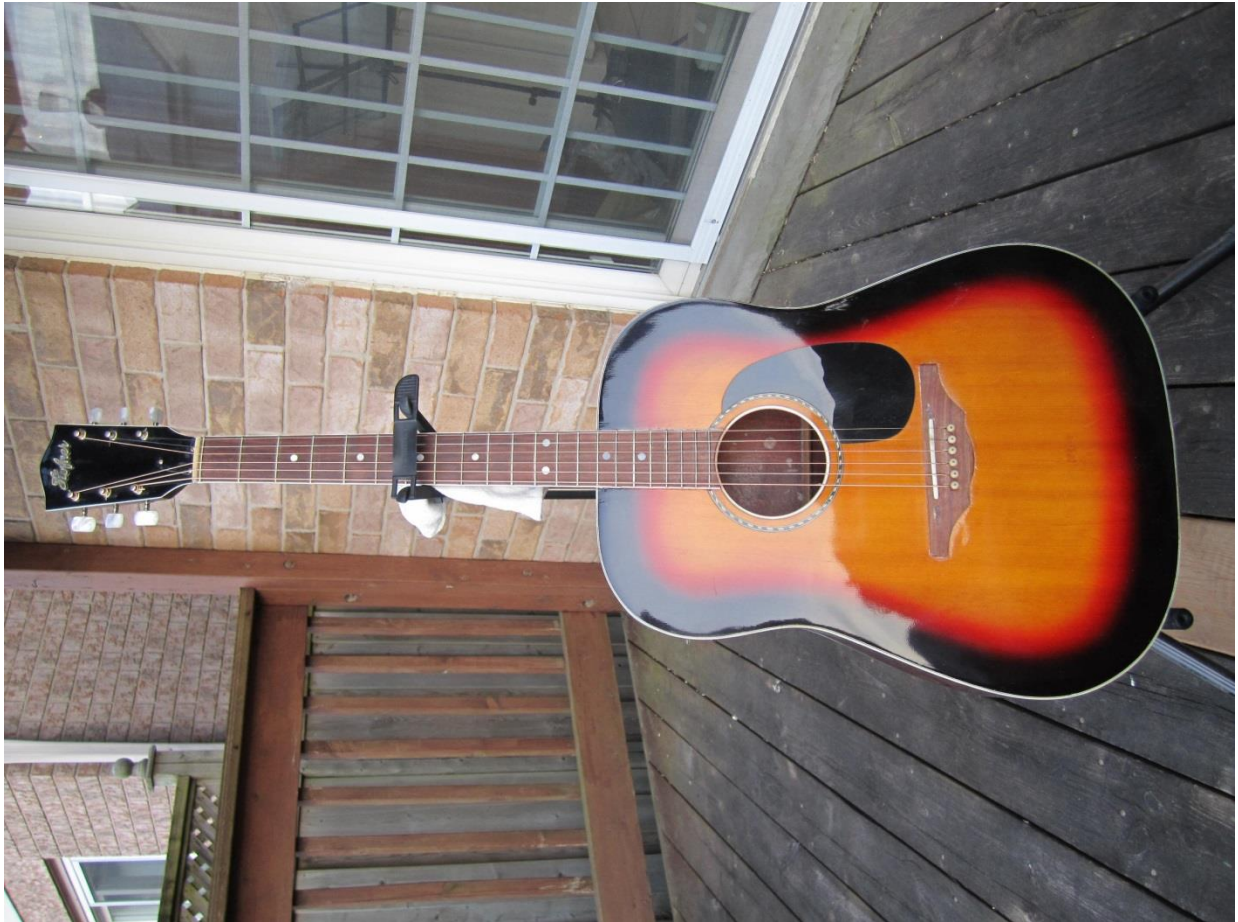
Everlasting beauty as when she was new.
